Manhole Inspection Summary

Manhole # S23CC1011MH

Location Address: **3600 CLIPPER MILL RD**

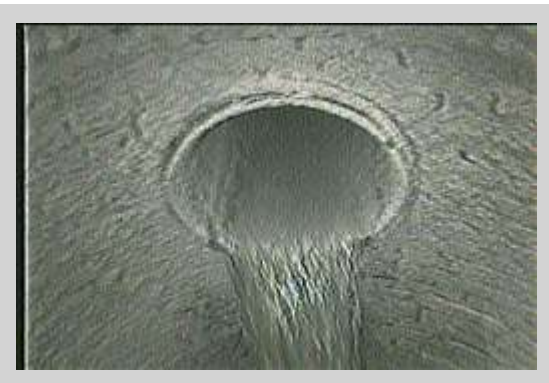
18 in. Circular Gravity Sewer Pipe In @ 4 O'Clock

Infiltration: **None** Pipe Seal Cond: **Unknown**

Drop Condition: **Clogged**
